## 2003 Dodge Ram Lumbar Support/Motor Fix

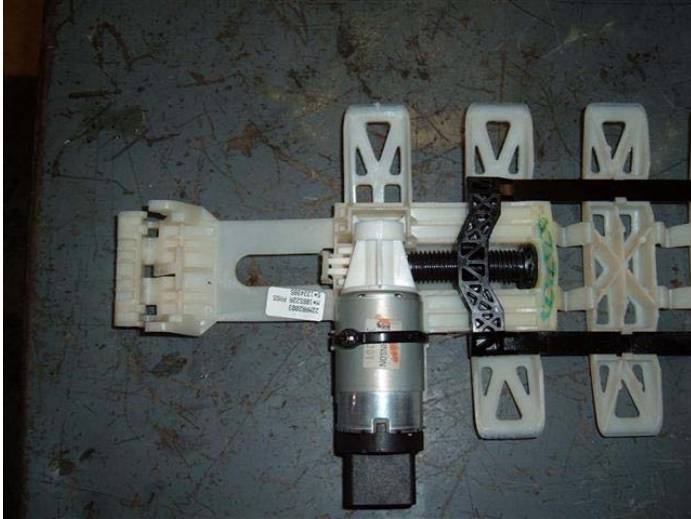
I've noticed several Ram's with the lumbar support either stuck or the motor is turning but the lumbar support does not move. What I've found is the actual bearing and worm-gear is slipping out of the motor due to no retaining clamp at the tip.

*Factory Design and assembly of the Lumbar Support Motor  
(Notice no clamp on top bearing/worm gear)*

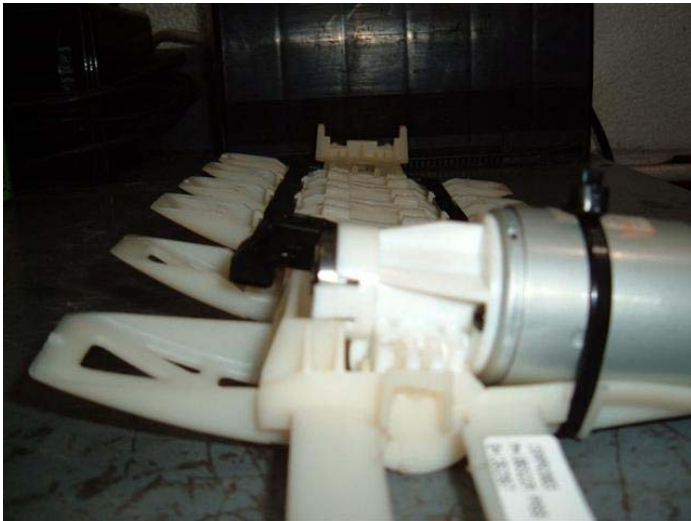
*This is what happens when there's no retainer or clamp for the motor  
(Notice bearing slipping out of clips and motor tilted)*

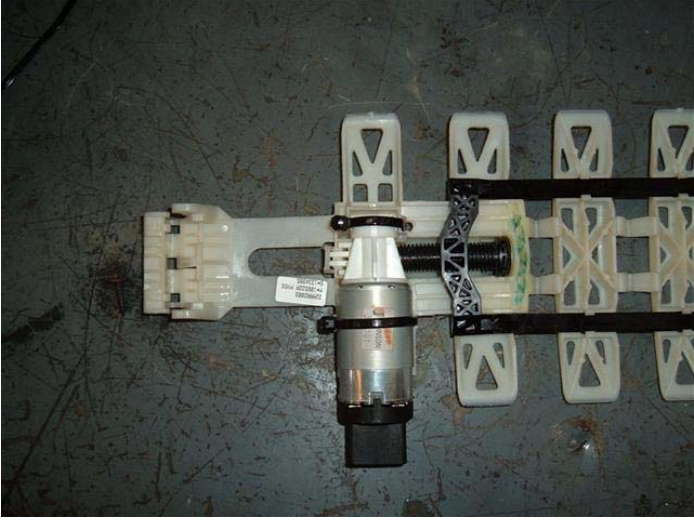
*Finished and ready for reinstallation*
